# **Integration of Remote Sensing Flood Maps and Measurements**

**G. Robert Brakenridge**

**For GFP 2017, June 27-29, Tuscaloosa, Alabama, USA**

# **Avoidance of Flood Disasters and the Benefits of International Cooperation**

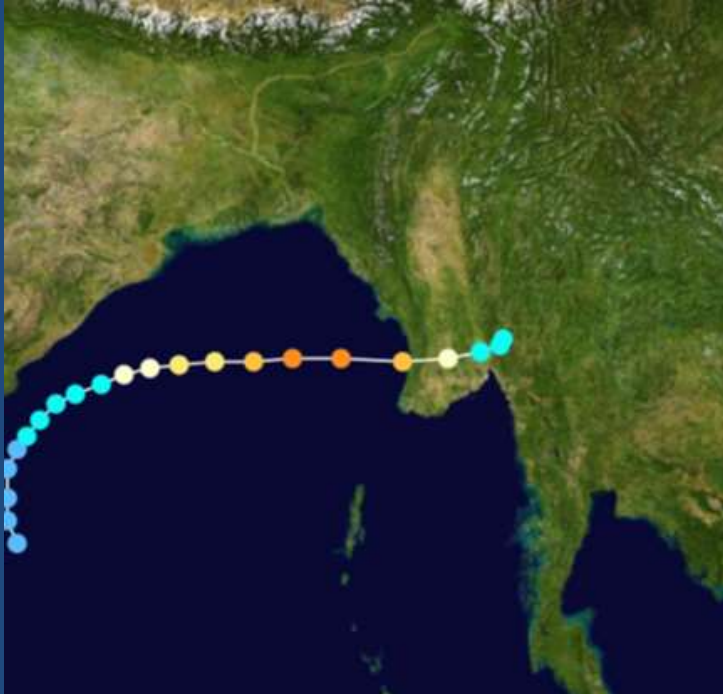
Left: track of the 1982 Cyclone Gwa. Blue: tropical depression; green: tropical storm; yellow to orange to red: category 1 to category 5 tropical cyclone. Six-hour intervals.

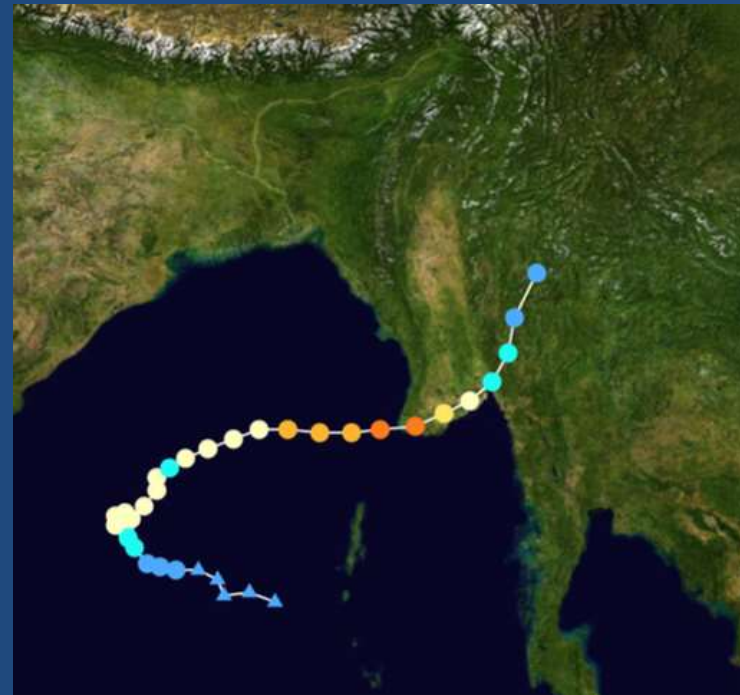
Cyclone Nargis, April 27–May 3, 2008, storm track (right). Nargis, followed an unusual (but not “unprecedented”) storm track. And in the 26 y since the last Nargis-like event (Gwa), both the region's total population and its location had very much changed.

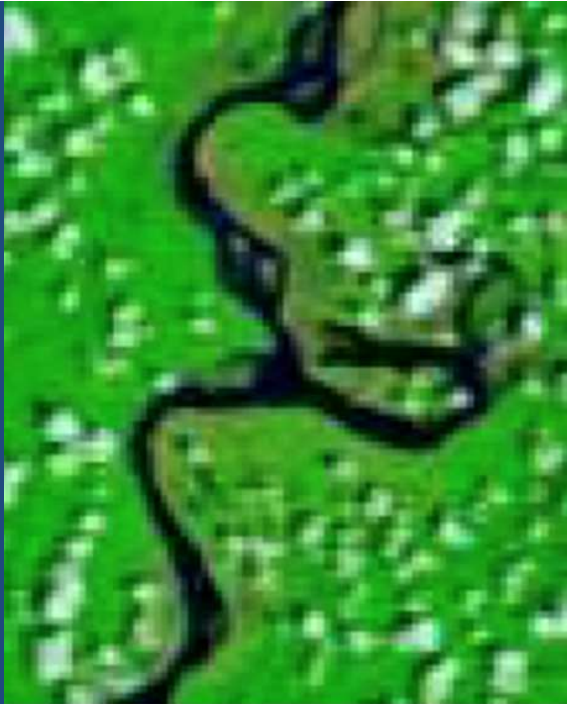
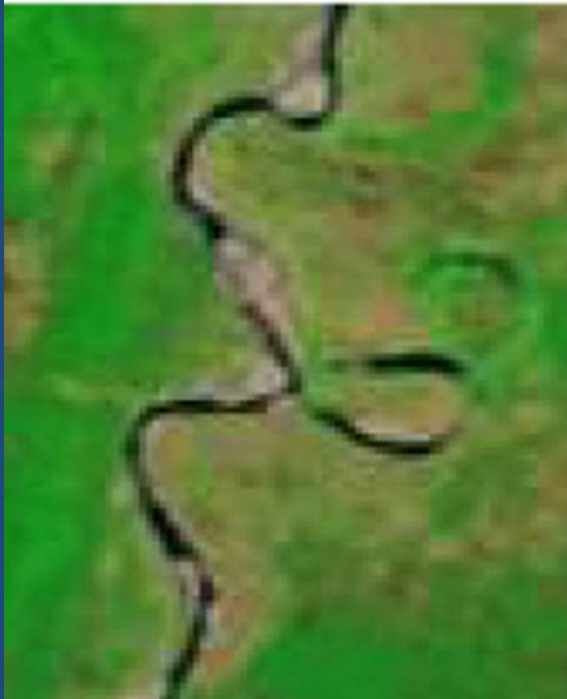
Left: MODIS band 7,2,1 colour composite (from NASA Worldview), September 11, 2015 (top), and March 13, 2015 (bottom) showing monsoon filling of the same Ayeyarwady river channel during the 2015 flood.

The (low-flow) abandoned meander is re-occupied annually during the monsoon season; it thus provides flood water storage and attenuates downstream-moving flood waves. If flood recover here removes access to the meander during flood (straightens and reinforces the channel), then downstream flooding will be worse.

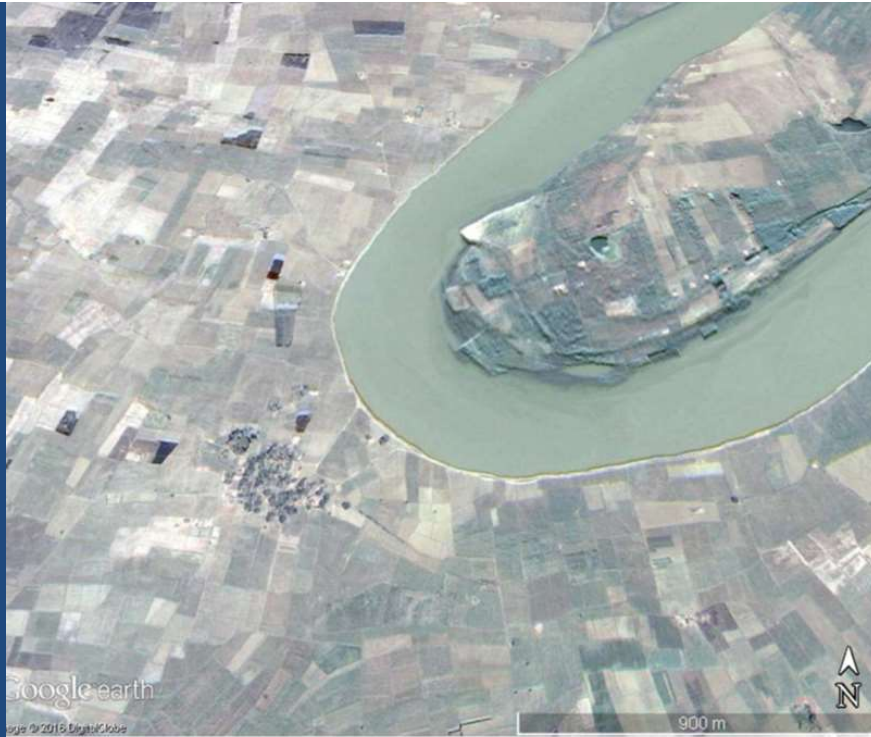
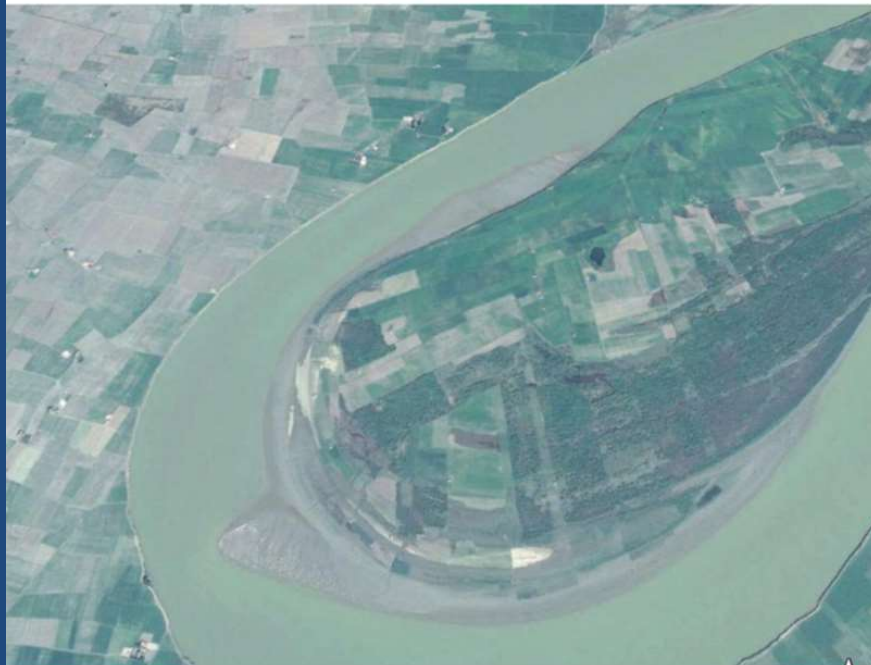
Sittaung River meander migration. The outer channel bank moved 620 m to the southwest between March 21, 2004 and January 20, 2014, for an average rate of 62 m/y. The newly created floodplain land is already being farmed. A village southwest of the river in 2004 was swallowed by the river and no longer exists.

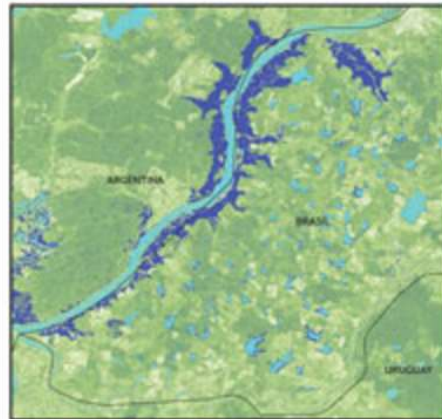
June 05, 2017  
International Charter Call ID 0118

**Inundaciones en Uruguay  
Flooding in Uruguay  
Comparison of two different dates**

Heavy rains caused severe flooding in Uruguay's Salto Department, Paysandú Department and Italo (main city of the Artigas department displacing 2000 people). Uruguay's National Emergency System (SNAE) are studying affected areas to assess the damage and prepare relief efforts. Many of the displaced people are already receiving food, shelter and medical care. Northern parts of Uruguay have been under a heavy rain warning since 24 May, and authorities expect further rain with flood waters set to continue rising.

CONAE (Argentine Space Agency) responded to Uruguay flooding in June, 2017. Uruguay's National Emergency System (SINAE) were visiting affected areas to assess the damage and prepare relief efforts. The International Charter for Space and Major Disasters was invoked on June 6. So far, so good.
