Integration of Remote Sensing Flood Maps and Measurements

G. Robert Brakenridge

Director, Dartmouth Flood Observatory (DFO)

Avoidance of Flood Disasters and the Benefits of International Cooperation

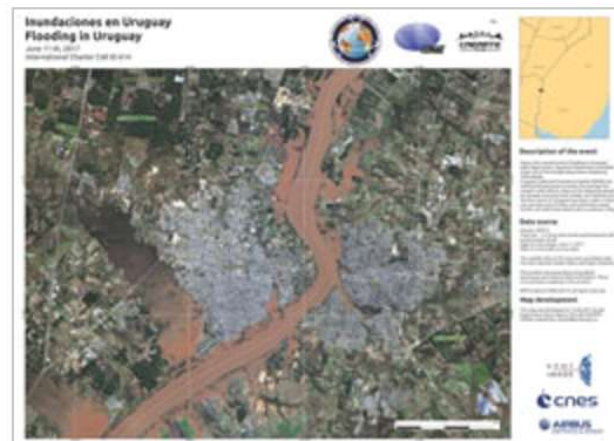
Flood at Salto

Source: SPOT-6

Acquired: 11/06/2017
